# UEFI, HP, and Me: A Bootloader Love-Hate Story

How one stubborn laptop taught me more about firmware psychology  
than I ever wanted to know

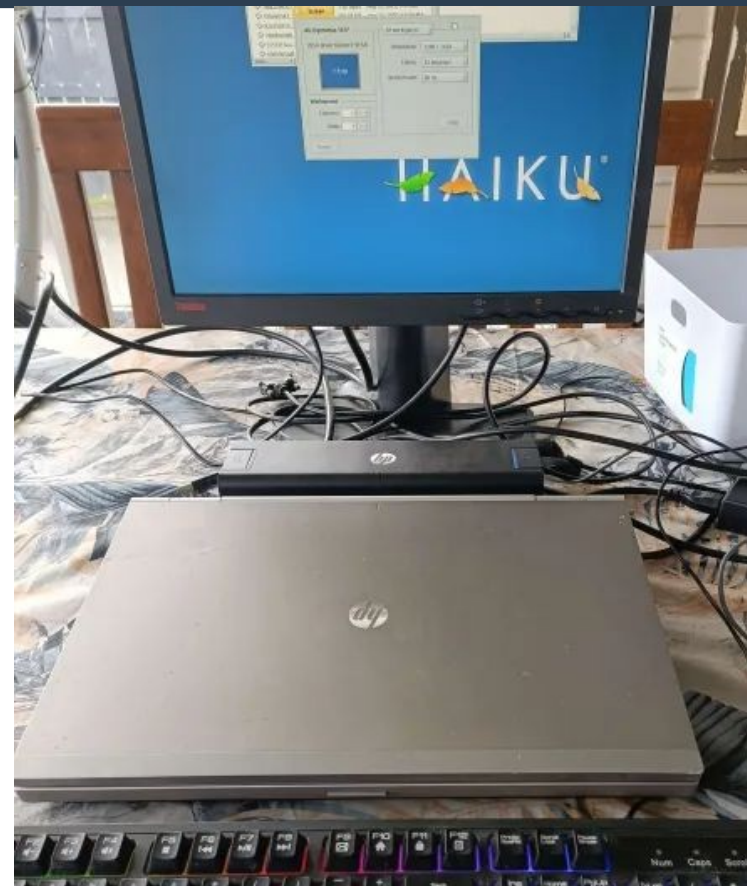
# Meet the Stubborn Hardware

- HP Elitebook 8560p (circa 2011)
- Early Insyde-based EFI firmware
- EFI support primarily intended for internal consumption (e.g. diagnostics and updates)
- Dual-drive setup: Crucial MX200 mSATA SSD (Expansion bay) + original WD Black HDD, both 500 GB
- Mission: A modern, reliable boot into any OS
